Appendix A.

Hydraulic Structure Data Collection

Central Coast Highway 1 Climate Resiliency Study
Figure A-1
 Hydraulic Structure Locations
 Surveyed by ESA on 11/13/2018

Central Coast Highway 1 Climate Resiliency Study

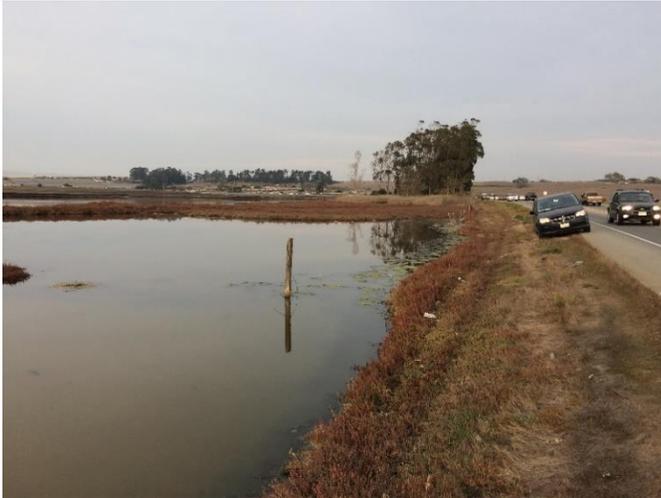
ID	Reach	Invert Elev. (ft, NAVD88)	Diameter (ft)	Material	Notes
R1-CULV-1	1	2.9	2	HDPE ¹	Culvert with concrete collar
R2-CULV-1	2	7.4	2	HDPE	Straight concrete wingwalls on both sides
R3-CULV-1	3	-1.6	6 (individual span)	Concrete	Dual box concrete culvert
R4-CULV-1	4	3.6	3	HDPE	-
R4-CULV-2	4	Unknown	1.5	HDPE	Culvert filled in. True invert of structure lower.

Reach 1 culvert located underneath vegetation)

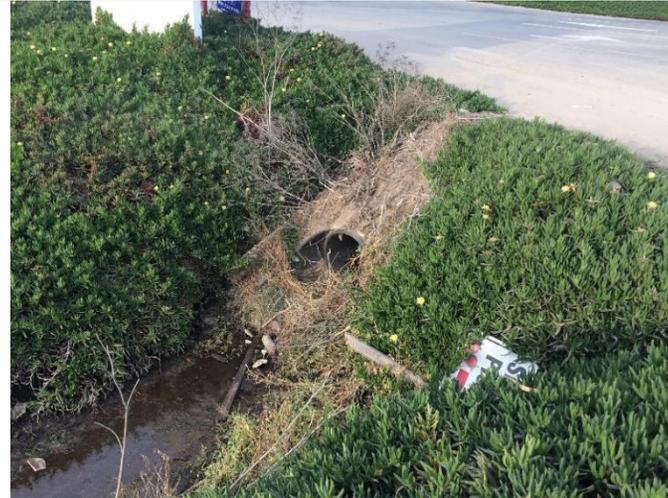
In Reach 2, the culverts connecting flow from Lower to Upper Bennett Slough were crushed; little to no tidal influence reaches Upper Bennett Slough and Struve Pond, which matched previous and existing qualitative observations of those hydrologic systems. Figure A-2 shows the condition of culverts surveyed. All survey data were taken with respect to

Reach 2 culvert by Bennett Slough

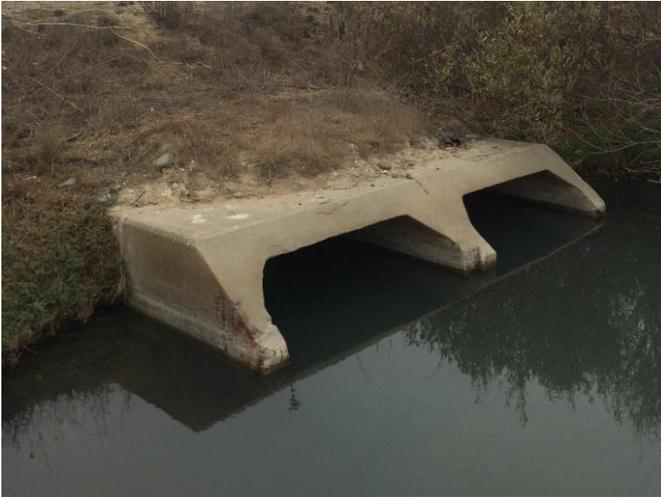
Reach 3 dual concrete culverts

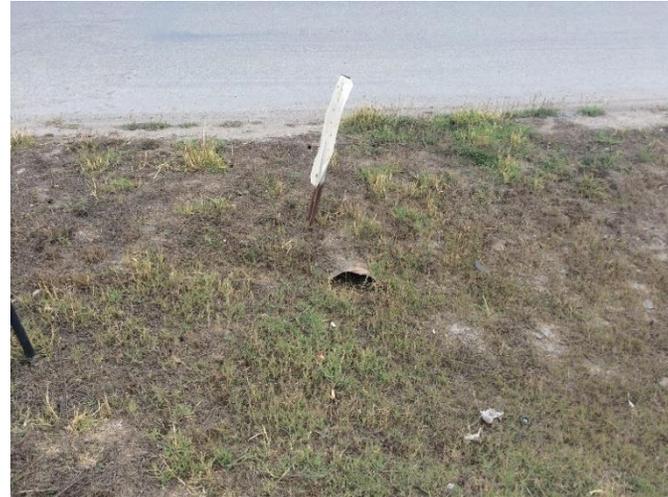
Reach 4 culvert (note structure is filled in)
