Appendix A.

Hydraulic Structure Data Collection

Central Coast Highway 1 Climate Resiliency Study
Figure A-1
 Hydraulic Structure Locations
 Surveyed by ESA on 11/13/2018

Central Coast Highway 1 Climate Resiliency Study

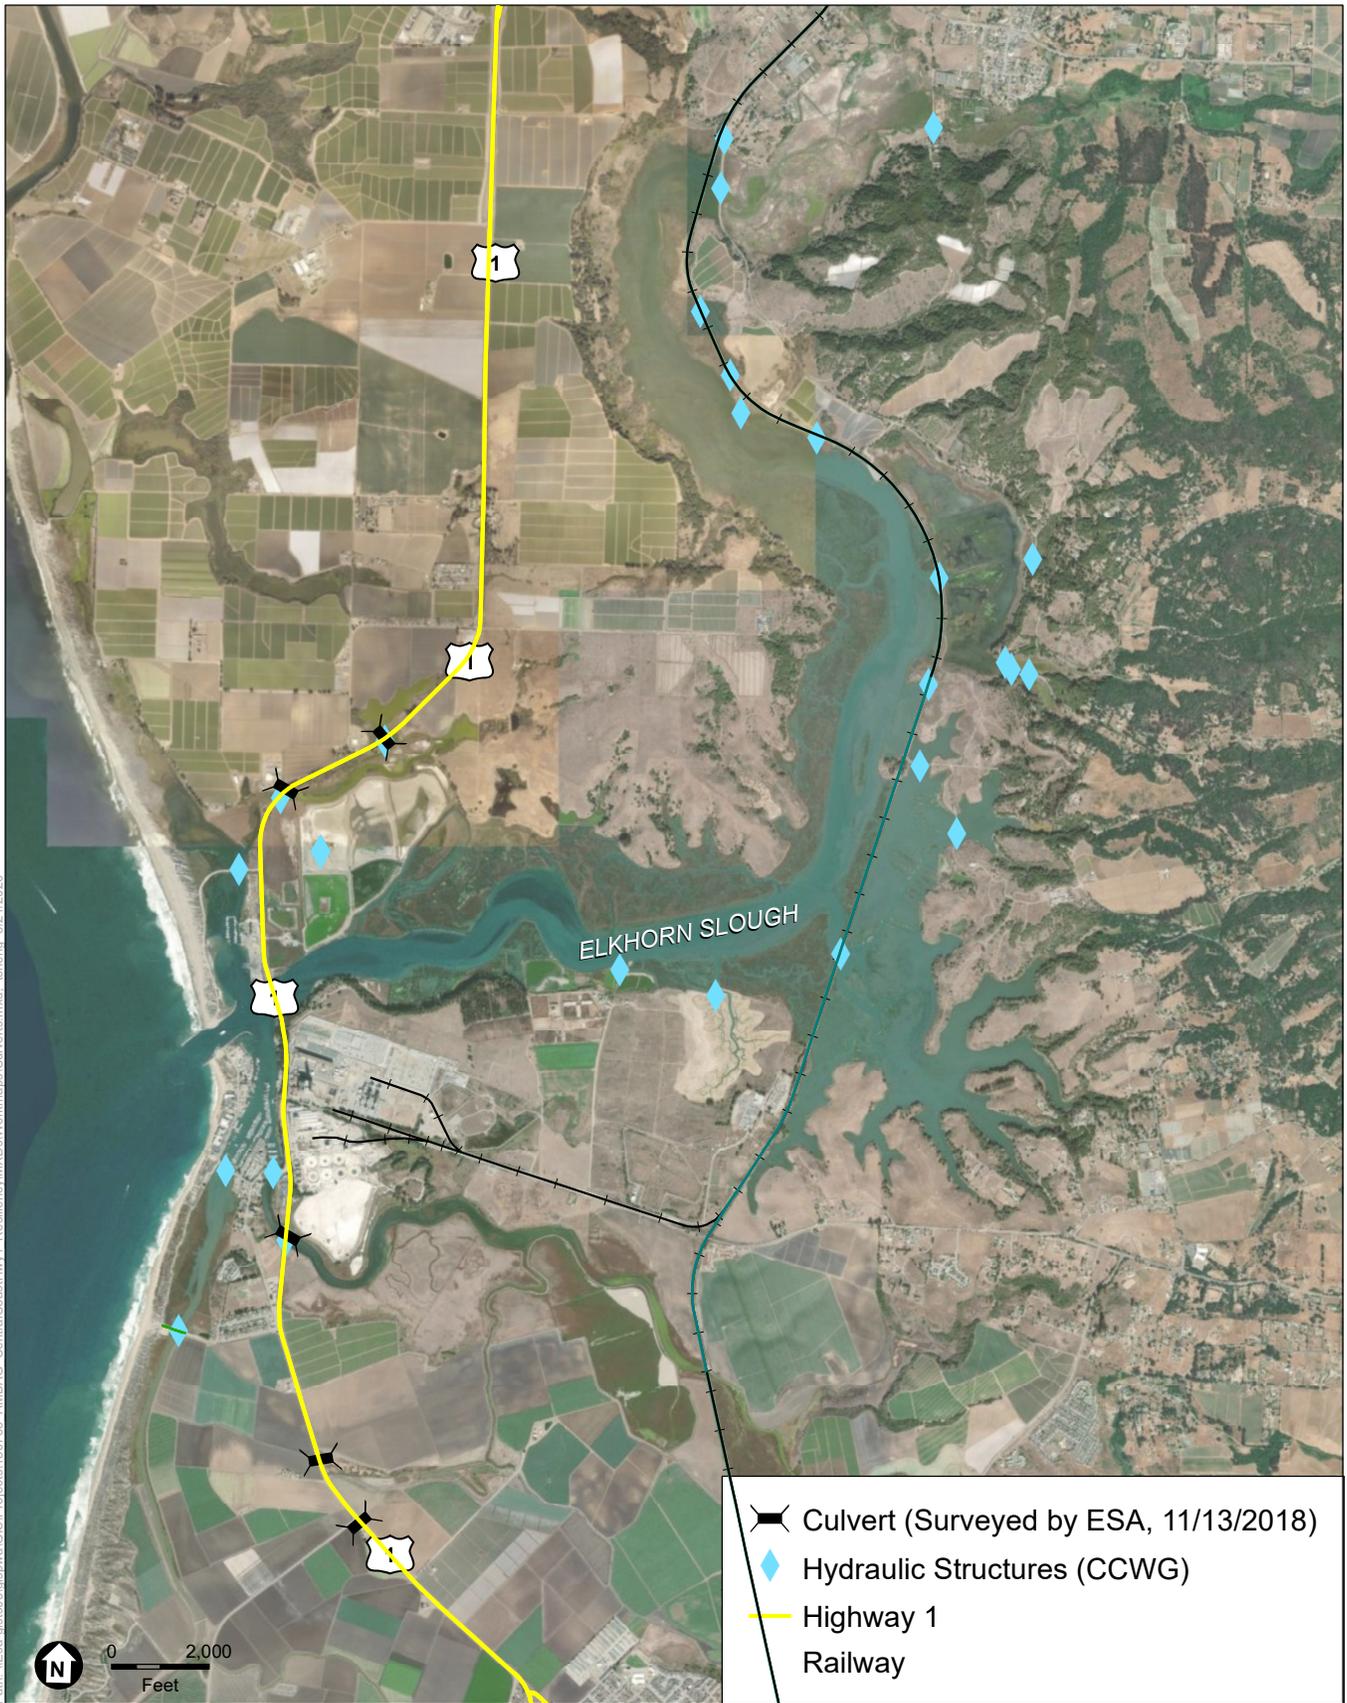
In Reach 2, the culverts connecting flow from Lower to Upper Bennett Slough were crushed; little to no tidal influence reaches Upper Bennett Slough and Struve Pond, which matched previous and existing qualitative observations of those hydrologic systems. Figure A-2 shows the condition of culverts surveyed. All survey data were taken with respect to
